Subject: Air Quality Assessment
Archuleta District Court
Pagosa Springs, Colorado
Project Number 174618

ATTACHMENT

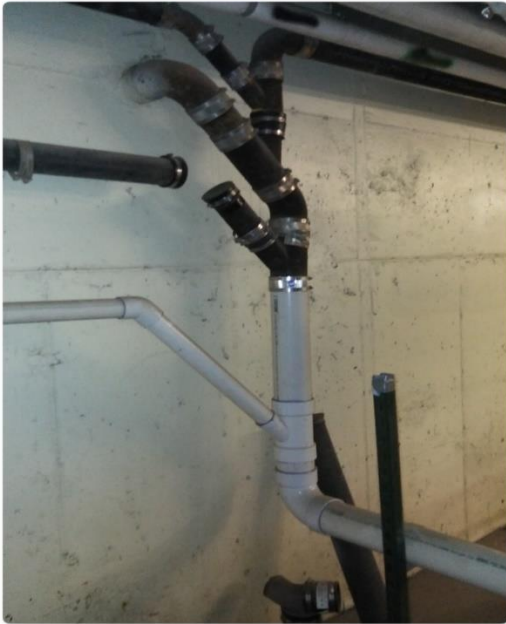
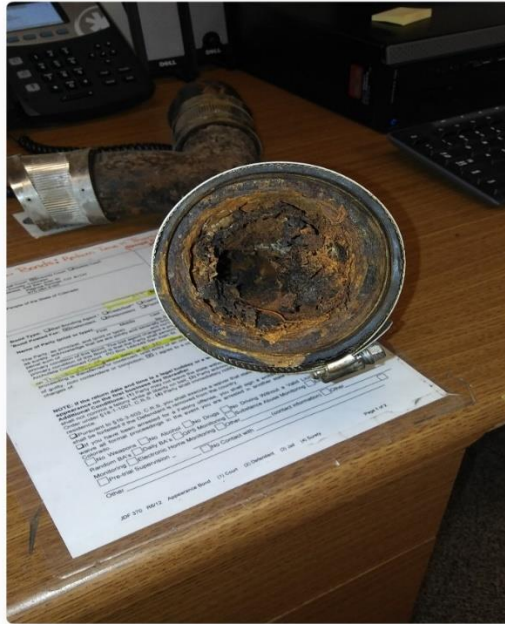
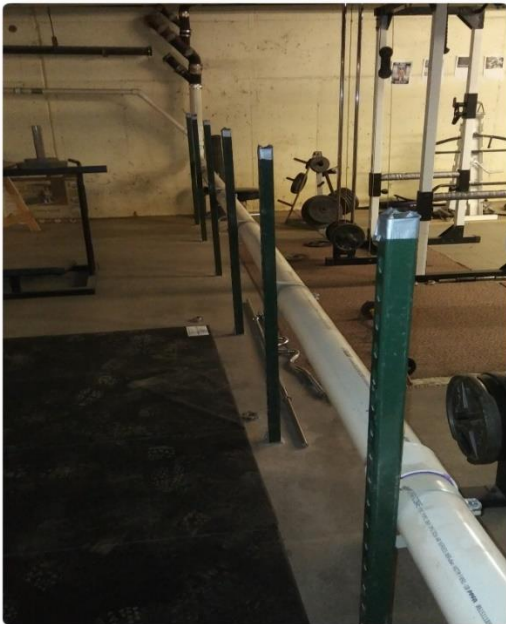
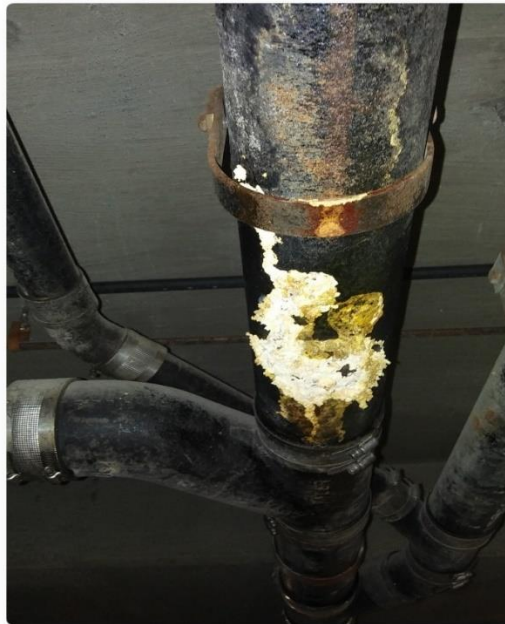
These photographs display the conditions of the plumbing in the jail area. Note that the cast iron has failed and has been replaced with PVC which is installed across the floor in the garage.

The Sheriff’s offices and the jail had a noticeable sulfur odor and carbon dioxide and carbon monoxide at levels higher than the outdoors. There were indications of roof leaks over the jail cells and the control room. AGW observed a musty odor in the jail area. Floor drains in the cells had been covered with plastic to stop odors from coming into the jail and offices. Some of the cast iron sewer lines have been abandoned and rerouted across the garage floor.
